Bulletin News

December 2015 - ISSUE #1

NEO tools

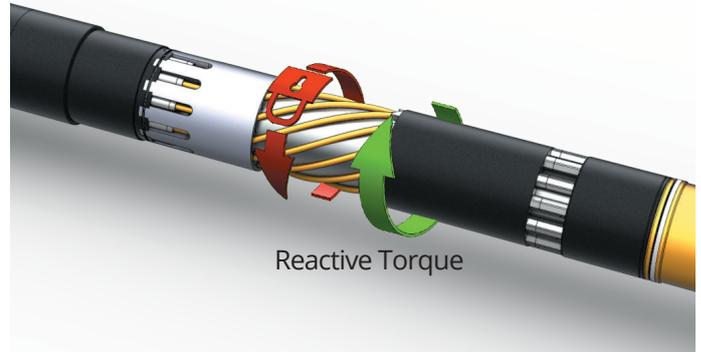
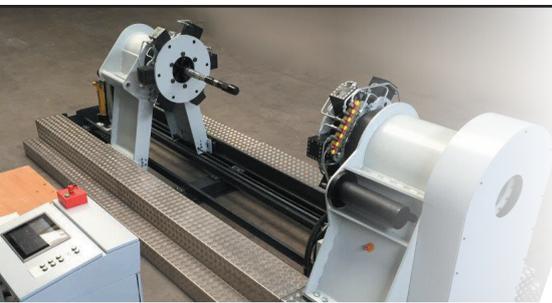
New NeoTork Upgrades

The recent test in the North Sea has illustrated that **NeoTork** can be, in some cases, exposed to below BHA backspin, forcing the cables to work in an inappropriate manner. The Neo-Oiltools engineering team has been swift to react to the challenge and has already designed a new assembly, that will be incorporated to **NeoTork**, in all its sizes, to block anti-clock wise rotation beyond the set limit. This new component, connected onto the hexagonal section located at the top of the main shaft, will have two keys that will allow clock wise rotation but that will butt on a shoulder should any anti-clock motion from the bottom BHA be generated beyond the natural limit allowing the tool to return to its full length.

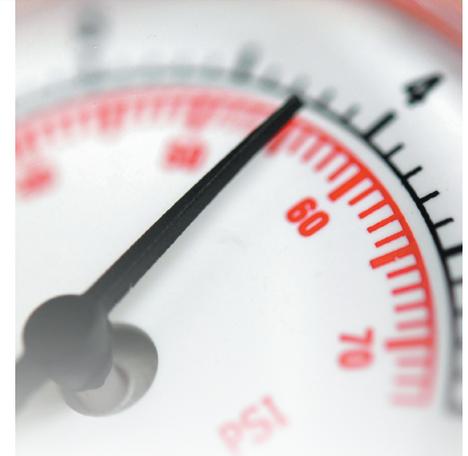
Pressure Warning System

To address this issue, we have now incorporated a new simple feature to **NeoTork** that will create a pressure indication clearly visible from surface should this scenario take place, indicating the need to pull out of the hole.

From now on, all **NeoTork** tools, regardless of the application, will be supplied with this device and all existing inventory will be upgraded.
